STABILIZATION PLAN
FOR
THE CHRISTENOT MILL
(24MA1215)

BLM Report No. 97-MT-070-076-06

Bureau of Land Management
Dillon Resource Area
1997

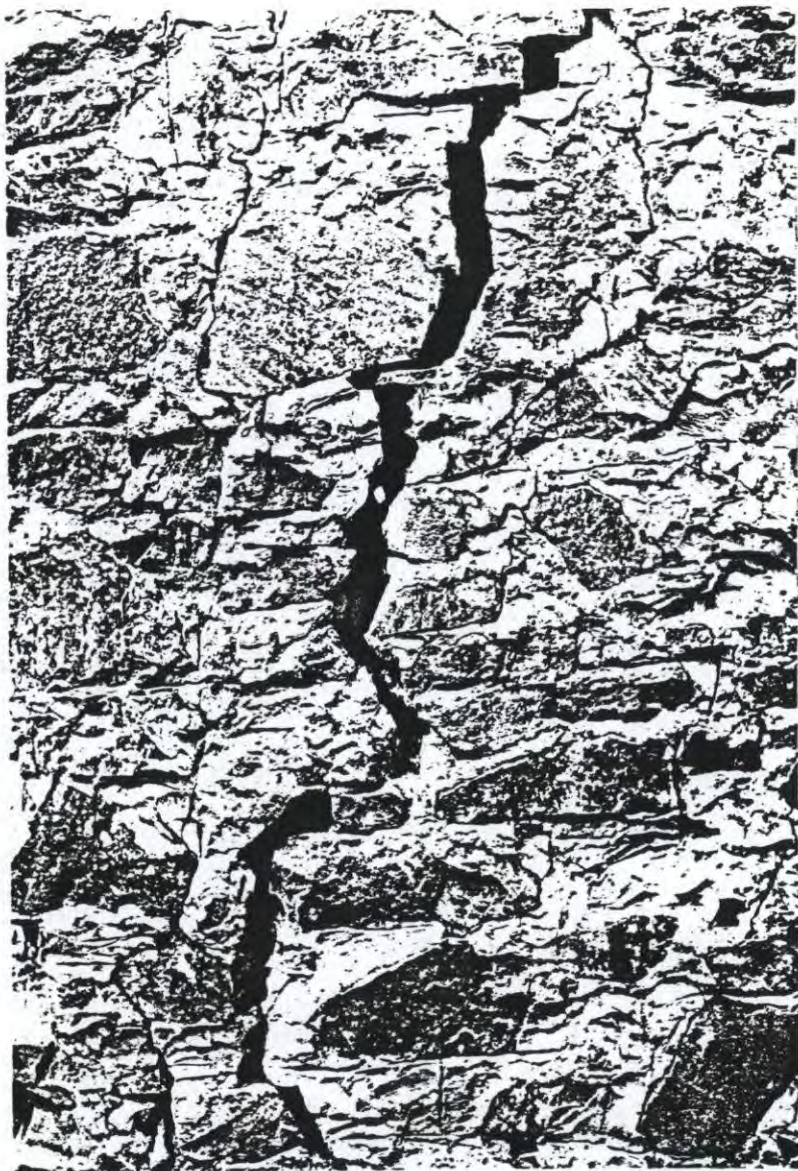
The stone walls are no longer protected from moisture and the elements. The upper wall segments are starting to lose mortar and exfoliate, due to the absorption of moisture and associated freeze/thaw cycles. Window and door framing materials are missing in several places and have resulted in the structural weakening of the upper wall segments (Figure 5). There are also several small trees growing on the interior of the building and/or immediately adjacent to fragile walls. Continued root and limb growth appear to be weakening the foundation and threatening the wall stability.

Figure 4. Christenot Mill (24MA1215) example of cracks in wall segment, view looking south. (Roll: MBS/96-10, Frame: 9)

2) Mortar work: Necessary mortar work will involve the repair and sealing of wall cracks, and the resetting of weathered and loose stones along the upper portions of the exposed walls. In order to protect the walls from moisture, a mortar cap (or coping) will be placed along the top of the walls as a moisture seal. Prior to mortar work, analysis of the historic mortar will be conducted (see Attachment 2) so that new mortar will match in color and texture and be consistent with the historic character of the original construction materials.

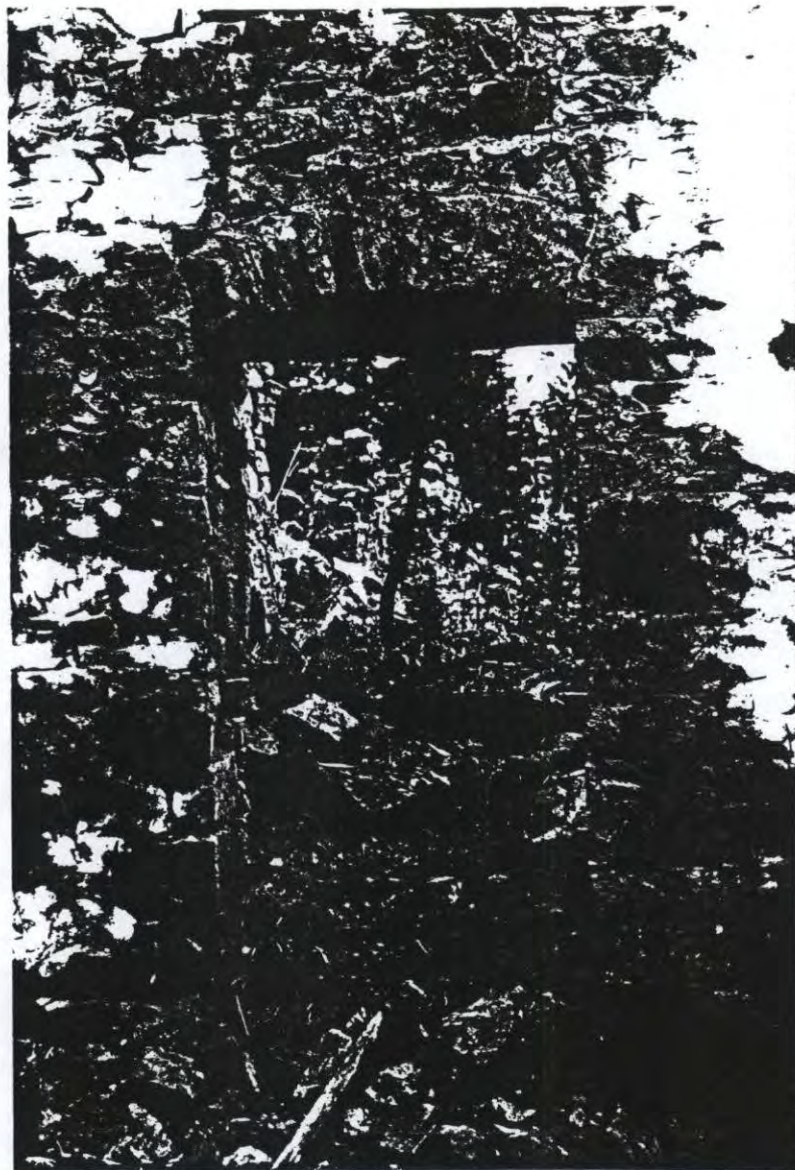
Figure 5. Christenot Mill (24MA1215) example of weakening of wall above unframed doorway, view looking west.
(Roll:MBS/96-10, Frame: 7)

3) Repair window and door frames: It is necessary to repair window and door frames in order to provide structural support for upper wall segments. Rough-cut milled lumber, of appropriate thickness and dimensions, will be used to match original construction materials as closely as possible in order to retain the historic character of the building. A photo and map record will be kept of the location and use of all new construction materials.

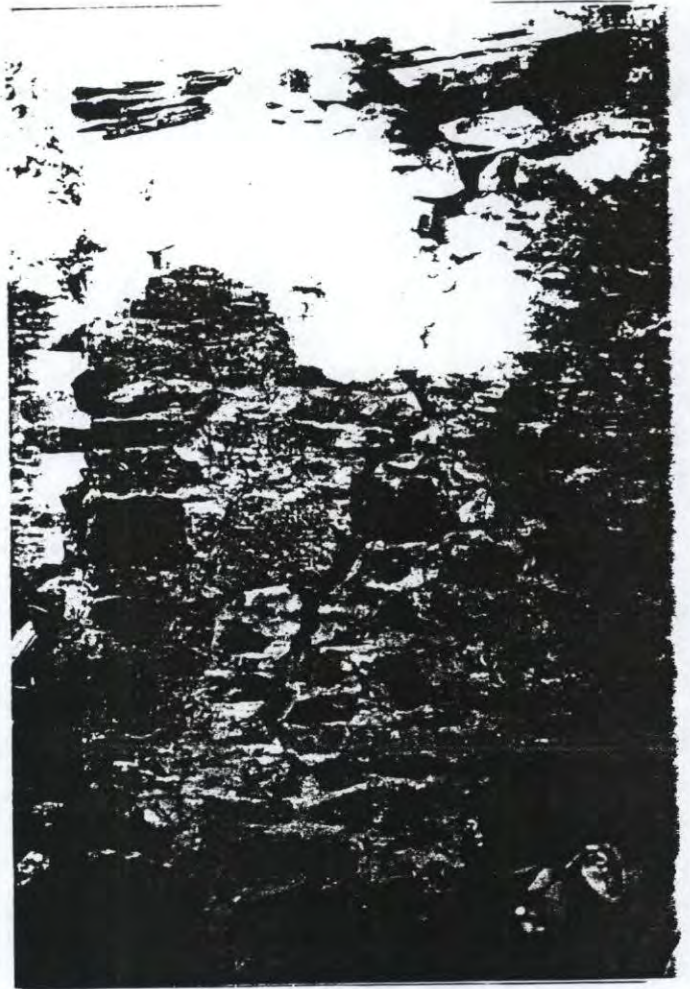
PHOTO 12
crack in wall E1
10/9/96
